Network Rail (London North West Territory)

Support for Listed Building Consent

Structure Name:	<i>Bridge 42</i>	Structure Number:	<i>42</i>
ELR:	<i>BEJ</i>	Mileage:	<i>10m 0462yds</i>
Structure Type:	<i>Underbridge</i>	OS Ref:	<i>SP 105 775</i>
Location:	<i>Whaley Bridge, Derbyshire</i>		
Report Ref:	<i>R2200-P7F98-LBC-04</i>	Revision:	<i>-</i>

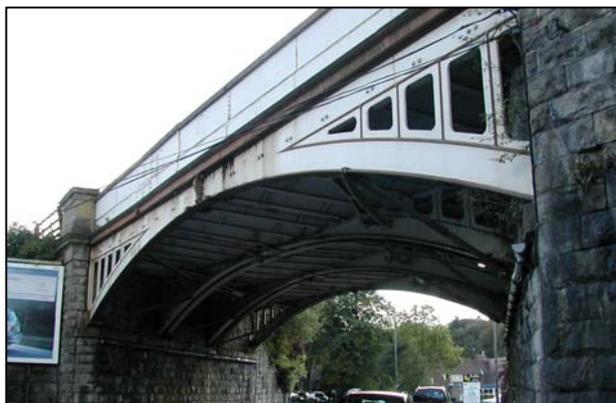
**Fig 1 : East Elevation**

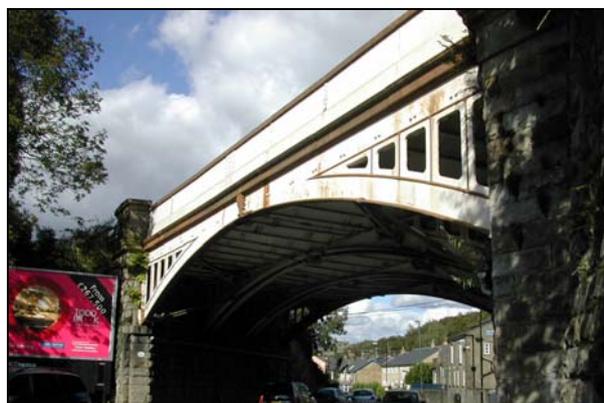
**Fig 2 : West Elevation**

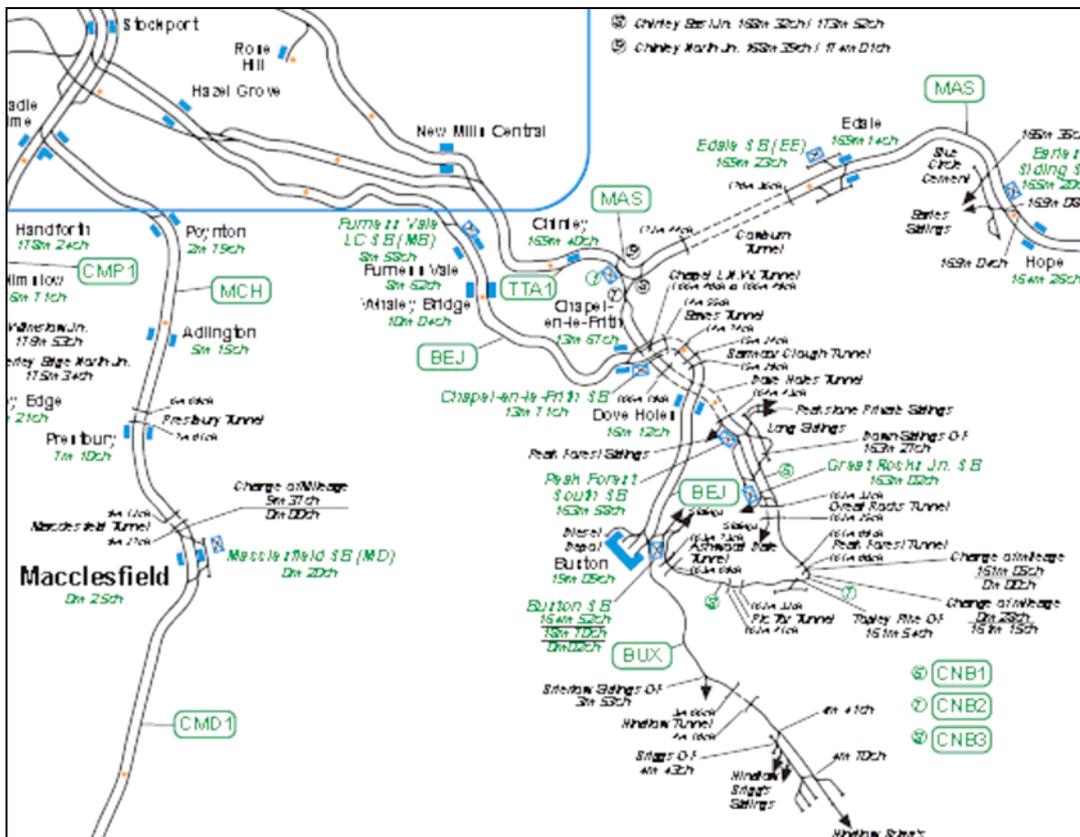
**LINE DIAGRAM TO DEMONSTRATE PATHING OPPORTUNITY FOR FRIEGHT OPERATING COMPANIES AND STAKEHOLDERS**

The map below identifies the bridge in context with the network, whilst the route diagram on the opposite page illustrates the pathing opportunities that could be achieved without the restrictions over Bridge 42.

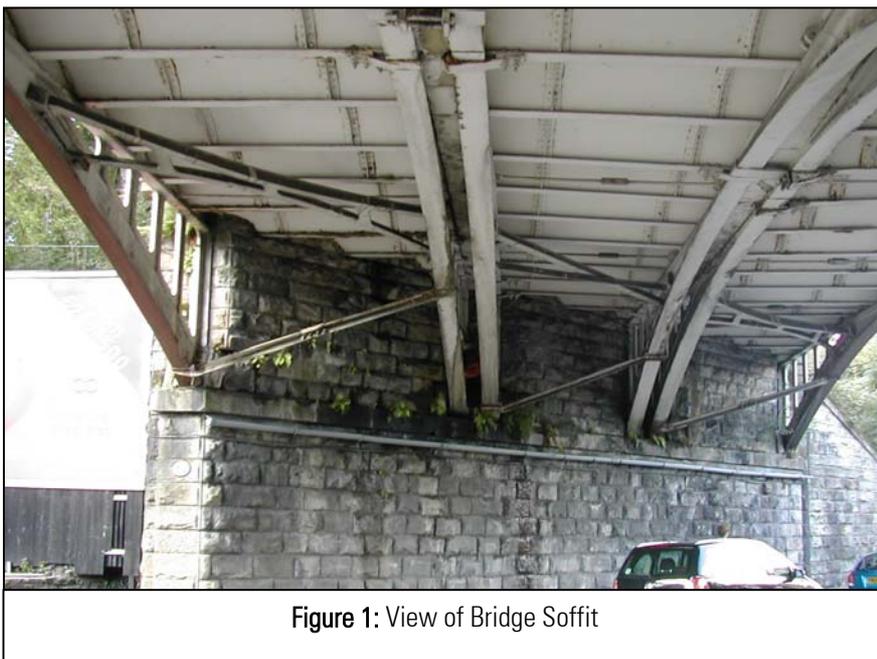
During the replacement of the floor in 1896 the archive drawings record the necessity to repair a crack in one of the cast iron arches. During the removal and replacement of the new deck elements, the opportunity was undertaken to repair the crack as depicted in Figure 5. It is important to note that it was necessary to remove the deck in the location of the defect to undertake the repair.

A number of the original cast iron bracing elements have also been replaced with Wrought Iron angle sections also depicted in figure 6.

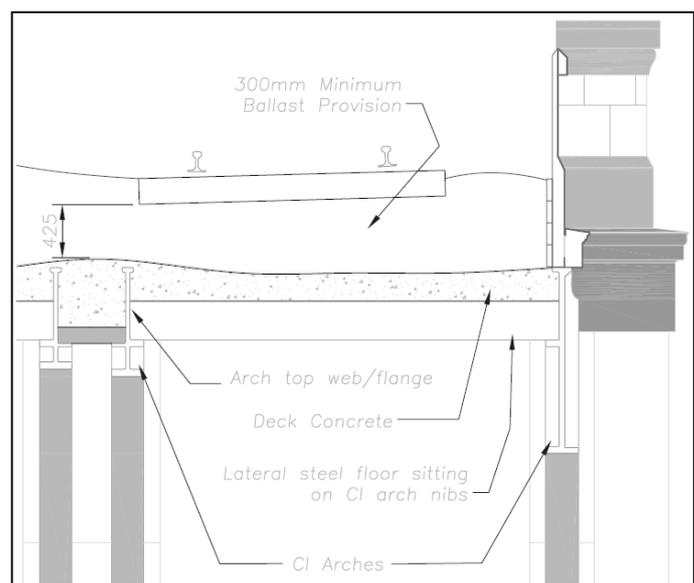
**Figure 2** – Cross section through existing deck  
Illustration of how construction space for new structural members is limited

- i. Existing Bridge Form of Construction  
The lateral steel/concrete floor, which spans between nibs of the CI arches, is at the same level as the arch top web/flange and thereby occupies the construction space available – refer to Figure 2 below.

The current track alignment can accommodate only increases of structural depth of approximately 125mm, with a strengthening solution to the top of the deck. Achieving capacity through strengthening in this available space is therefore considered to be impractical, without vertical realignment of the track.

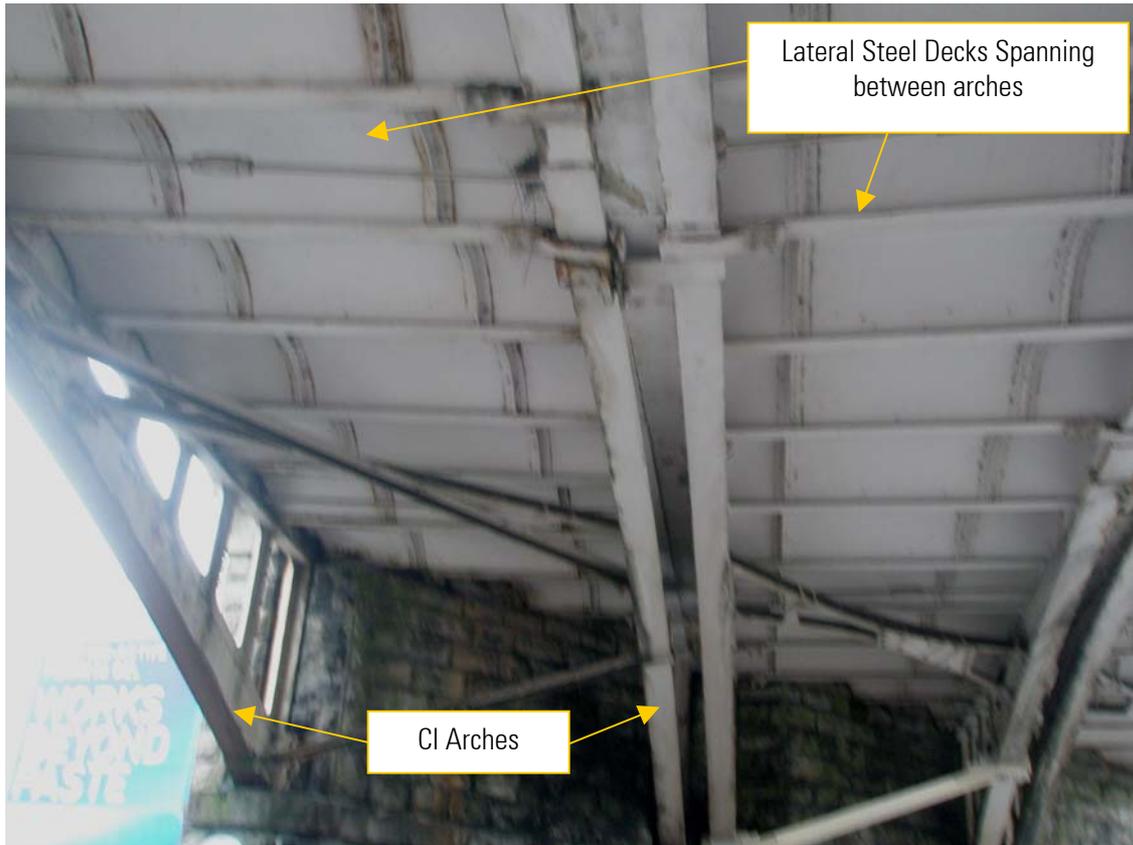
**Figure 3** – Arrangement of Arches and Deck Soffit

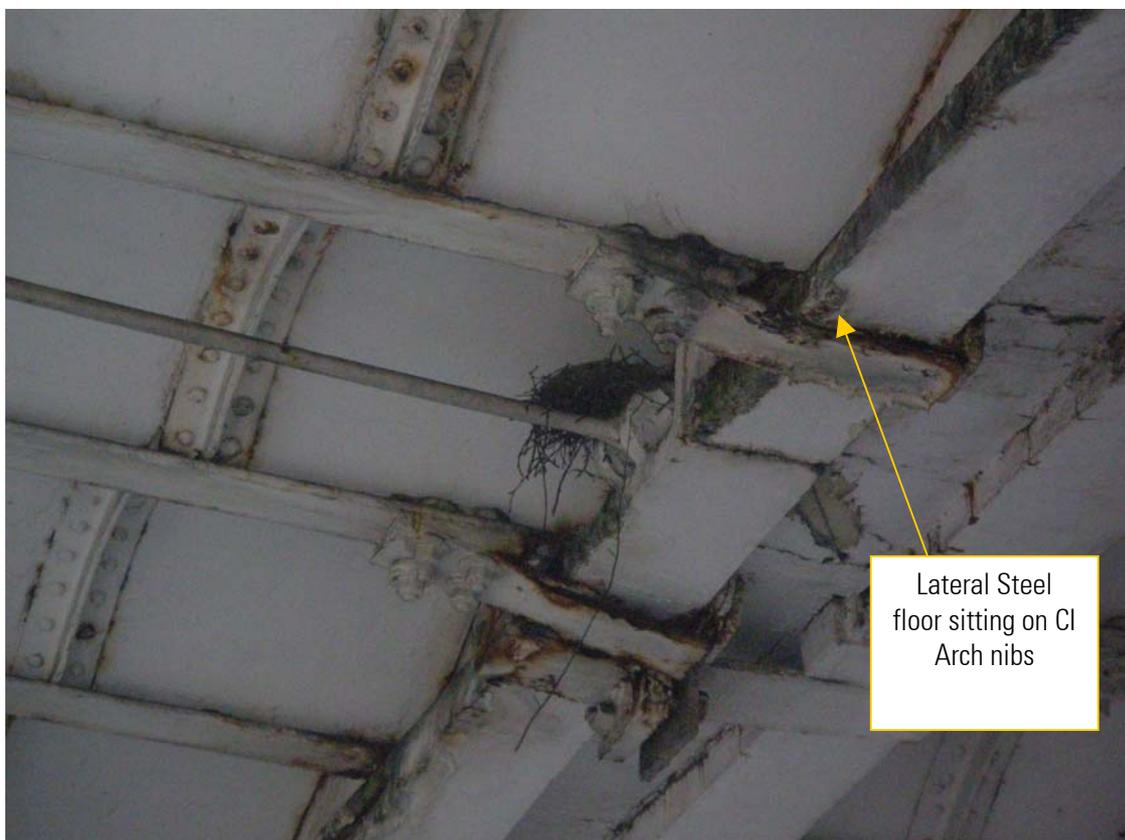
**Figure 4** – Detail of steel floor supported on CI nib

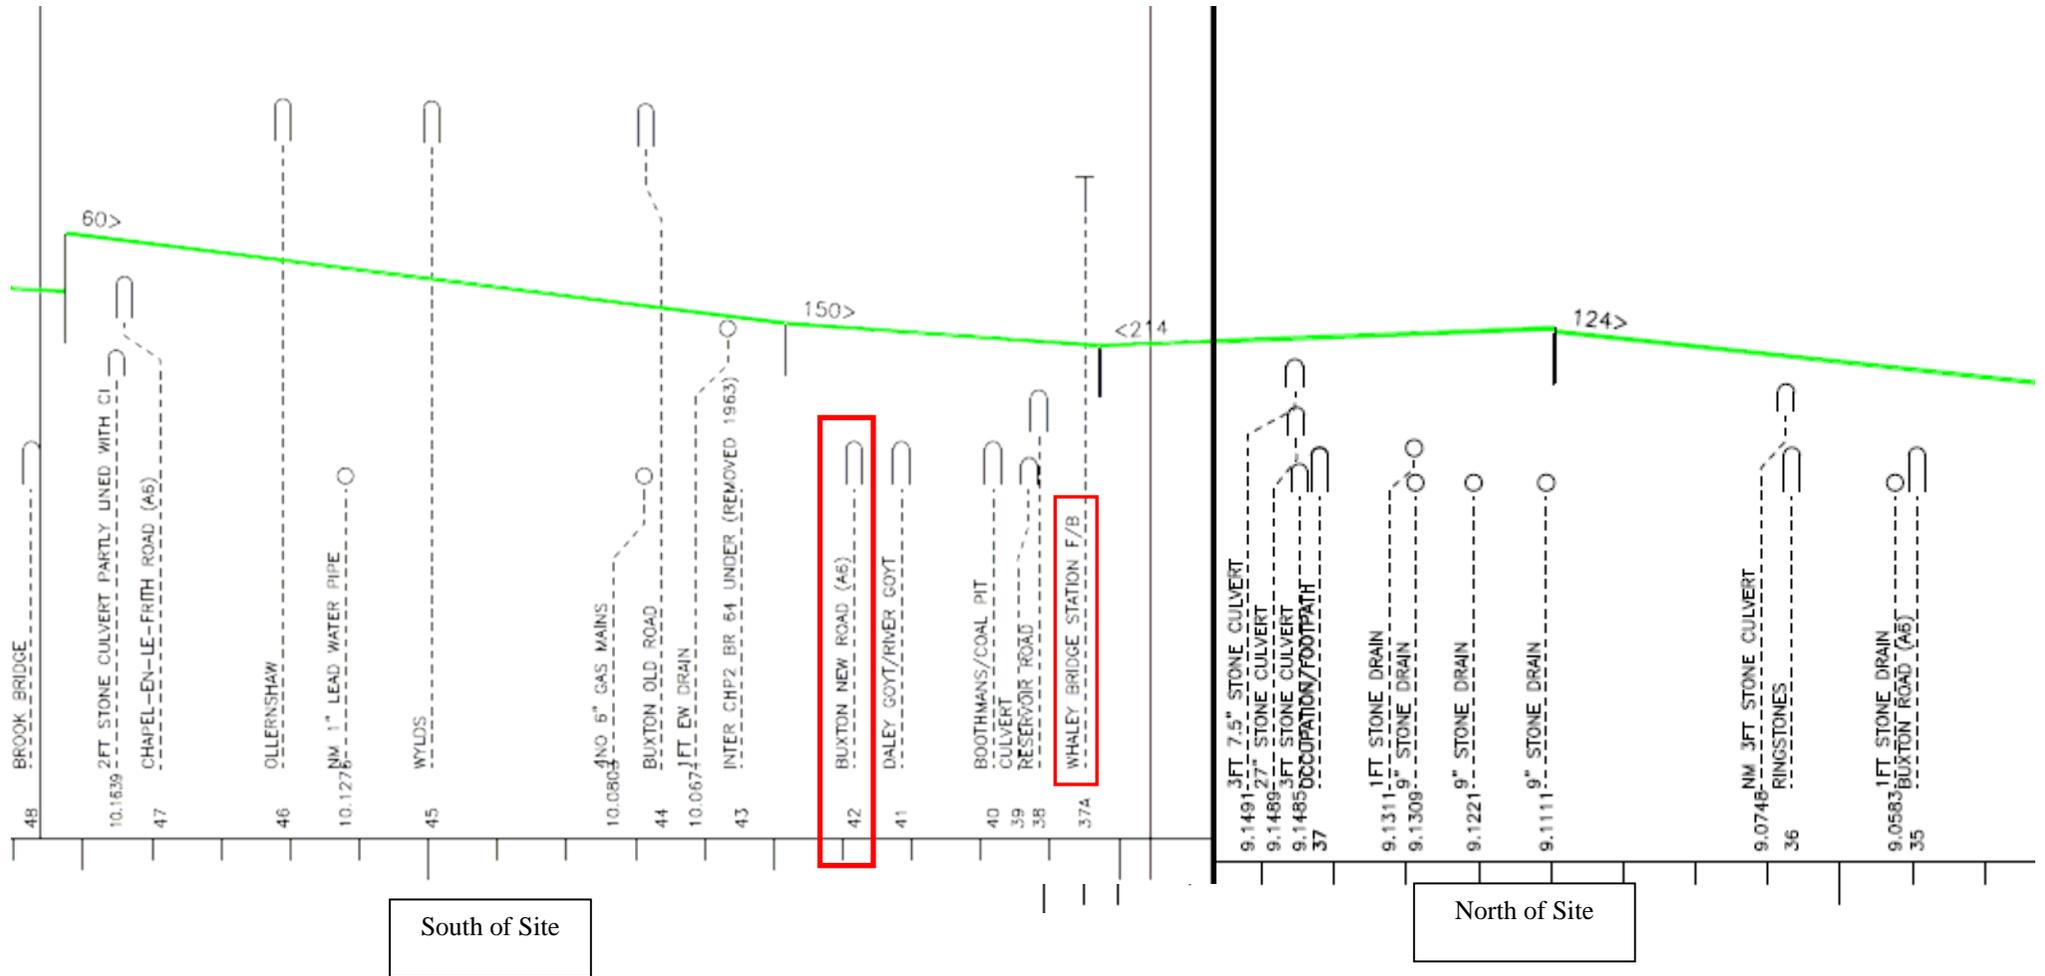
Figure 5 – Schematic of Track Vertical Alignment in Whaley Bridge Area (source: NR Five Mile Plans)

The current railway alignment over the bridge is 1:150. Refer to Figure 5 (overleaf).

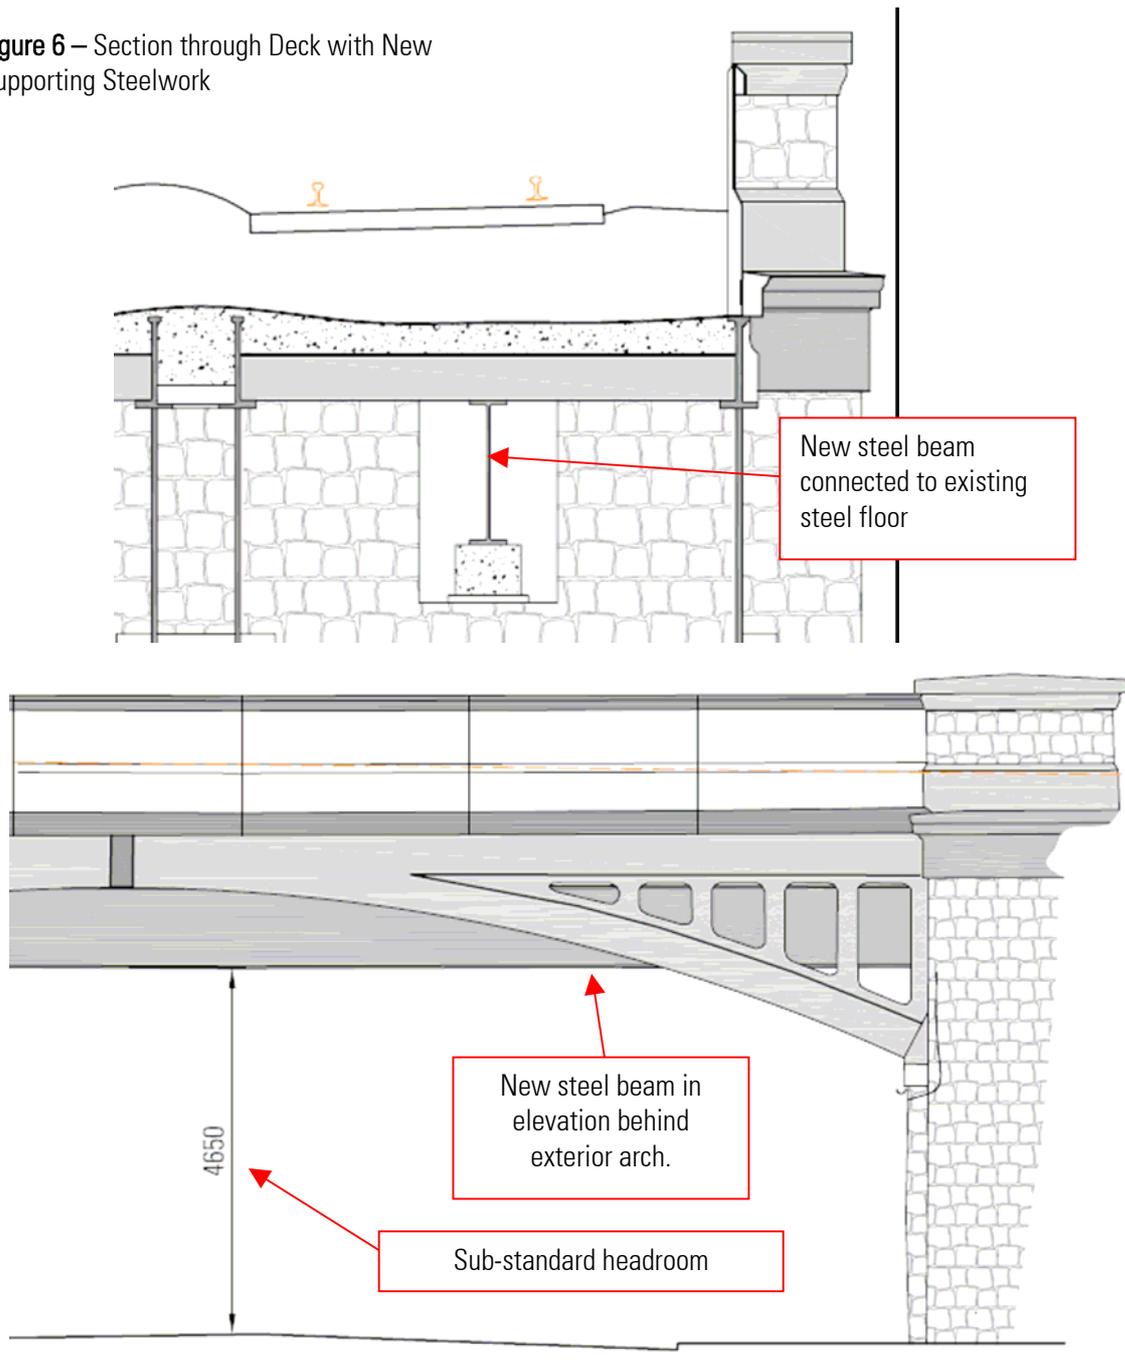
**Figure 6** – Section through Deck with New Supporting Steelwork

**Figure 4.0X** – Part Elevation of New Secondary Steelwork

- i. No works required to the top of the existing bridge deck;
- ii. New supporting steelwork to be installed below the existing arches only to relieve the overstressed lateral steel floor, which is retained;
- iii. Loads are shared between new steelwork and existing CI arches

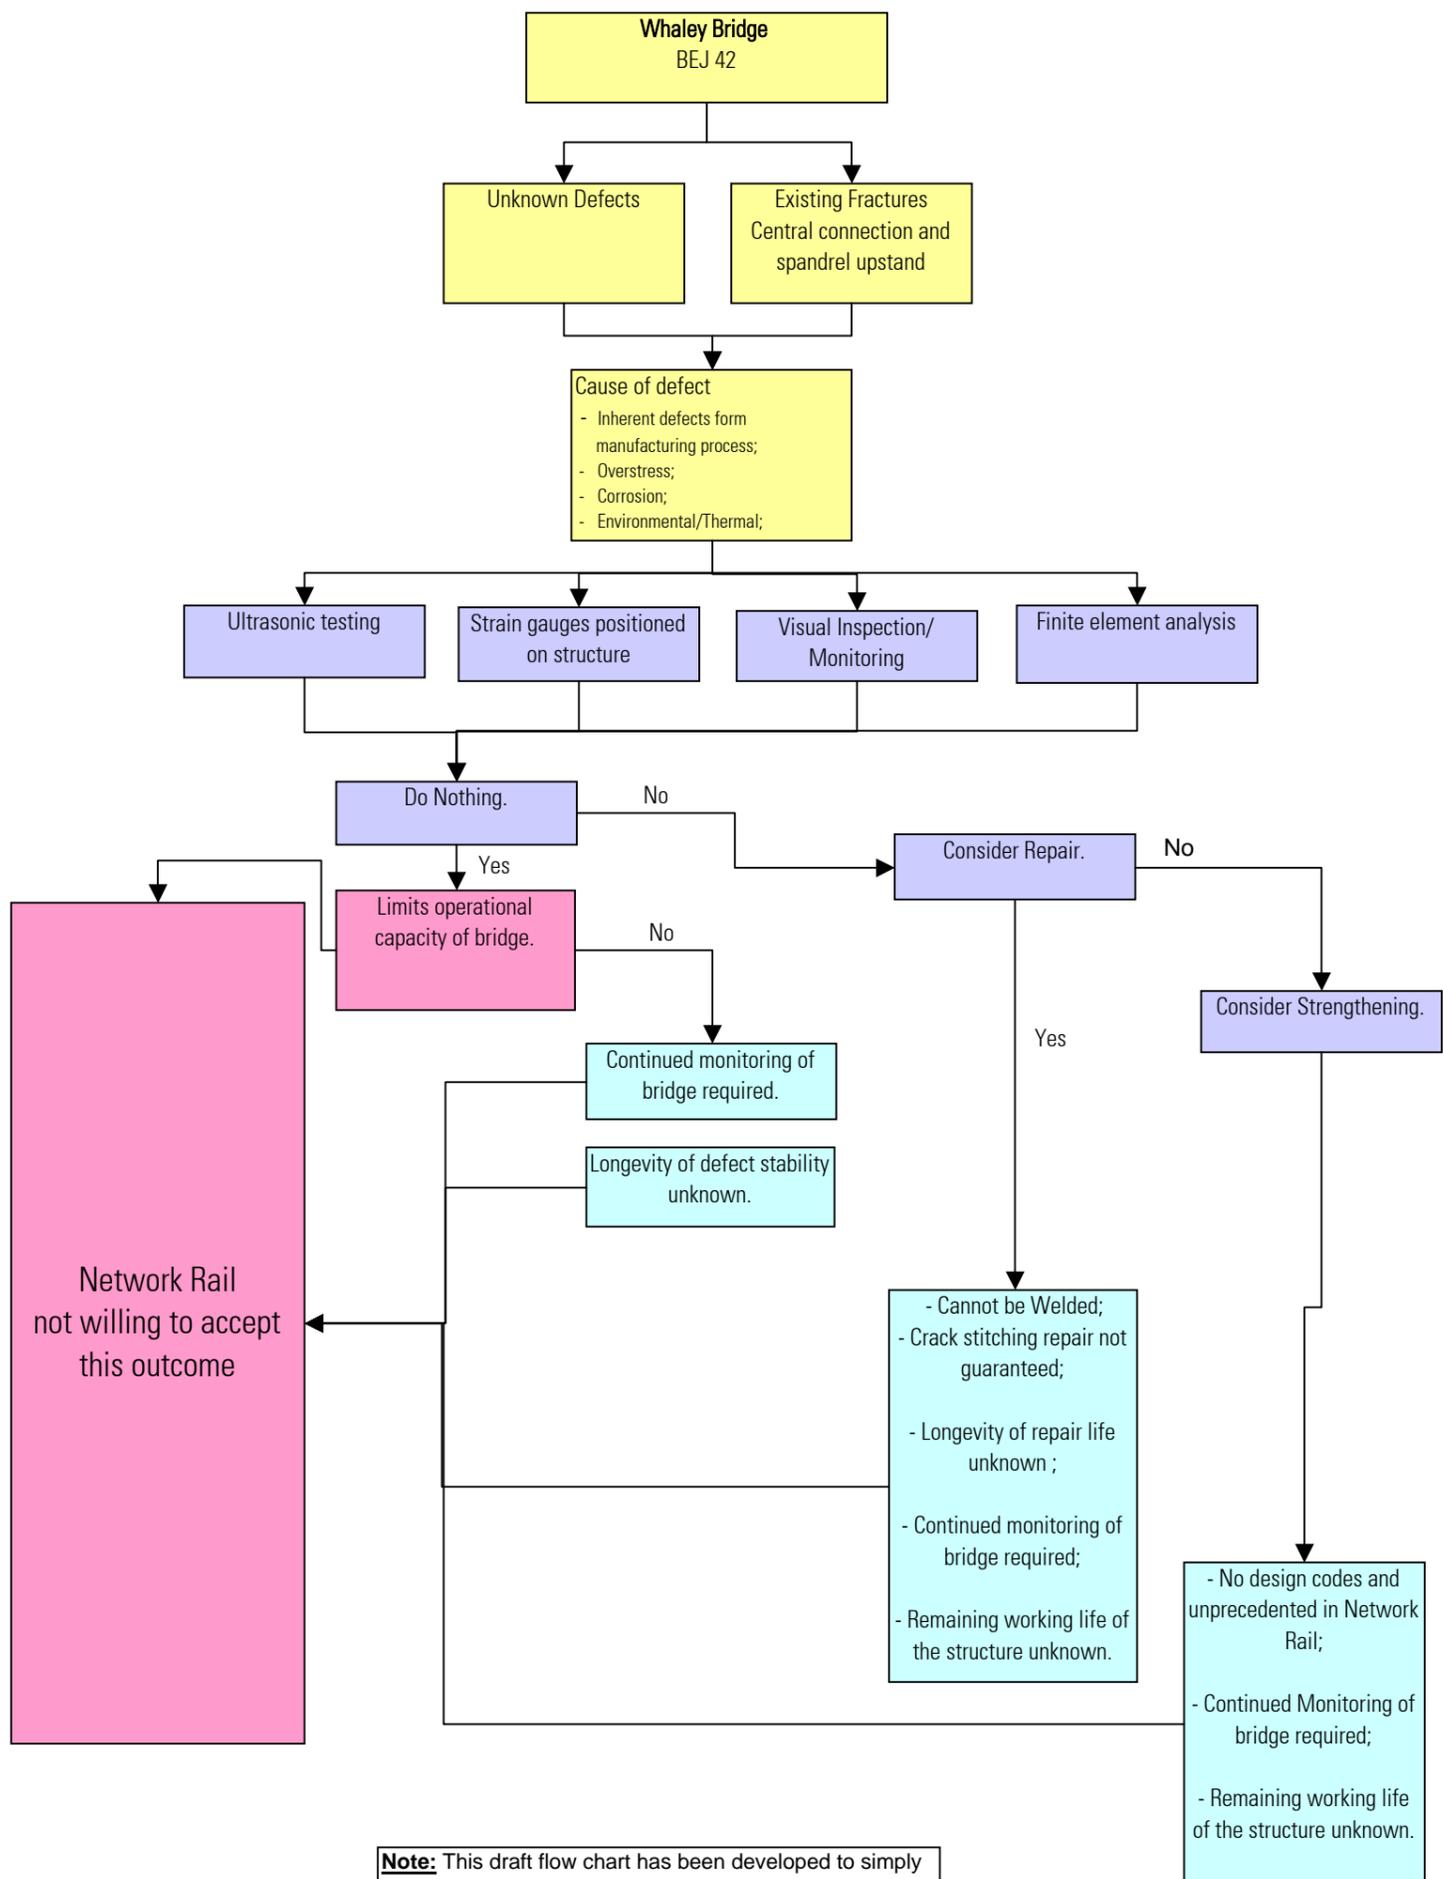
**Note:** This draft flow chart has been developed to simply and clearly indicate to the approving bodies Network Rail's position with regards to options other than reconstructions.

It shows that no matter what the outcome from any further detailed investigations / analysis that 'do nothing', 'repair' and strengthening are not satisfactory options for this particular case. It is hoped that this be developed further with feedback from Network Rail to strengthen the outcome that no matter how much time and resource are input into the options they are not acceptable.

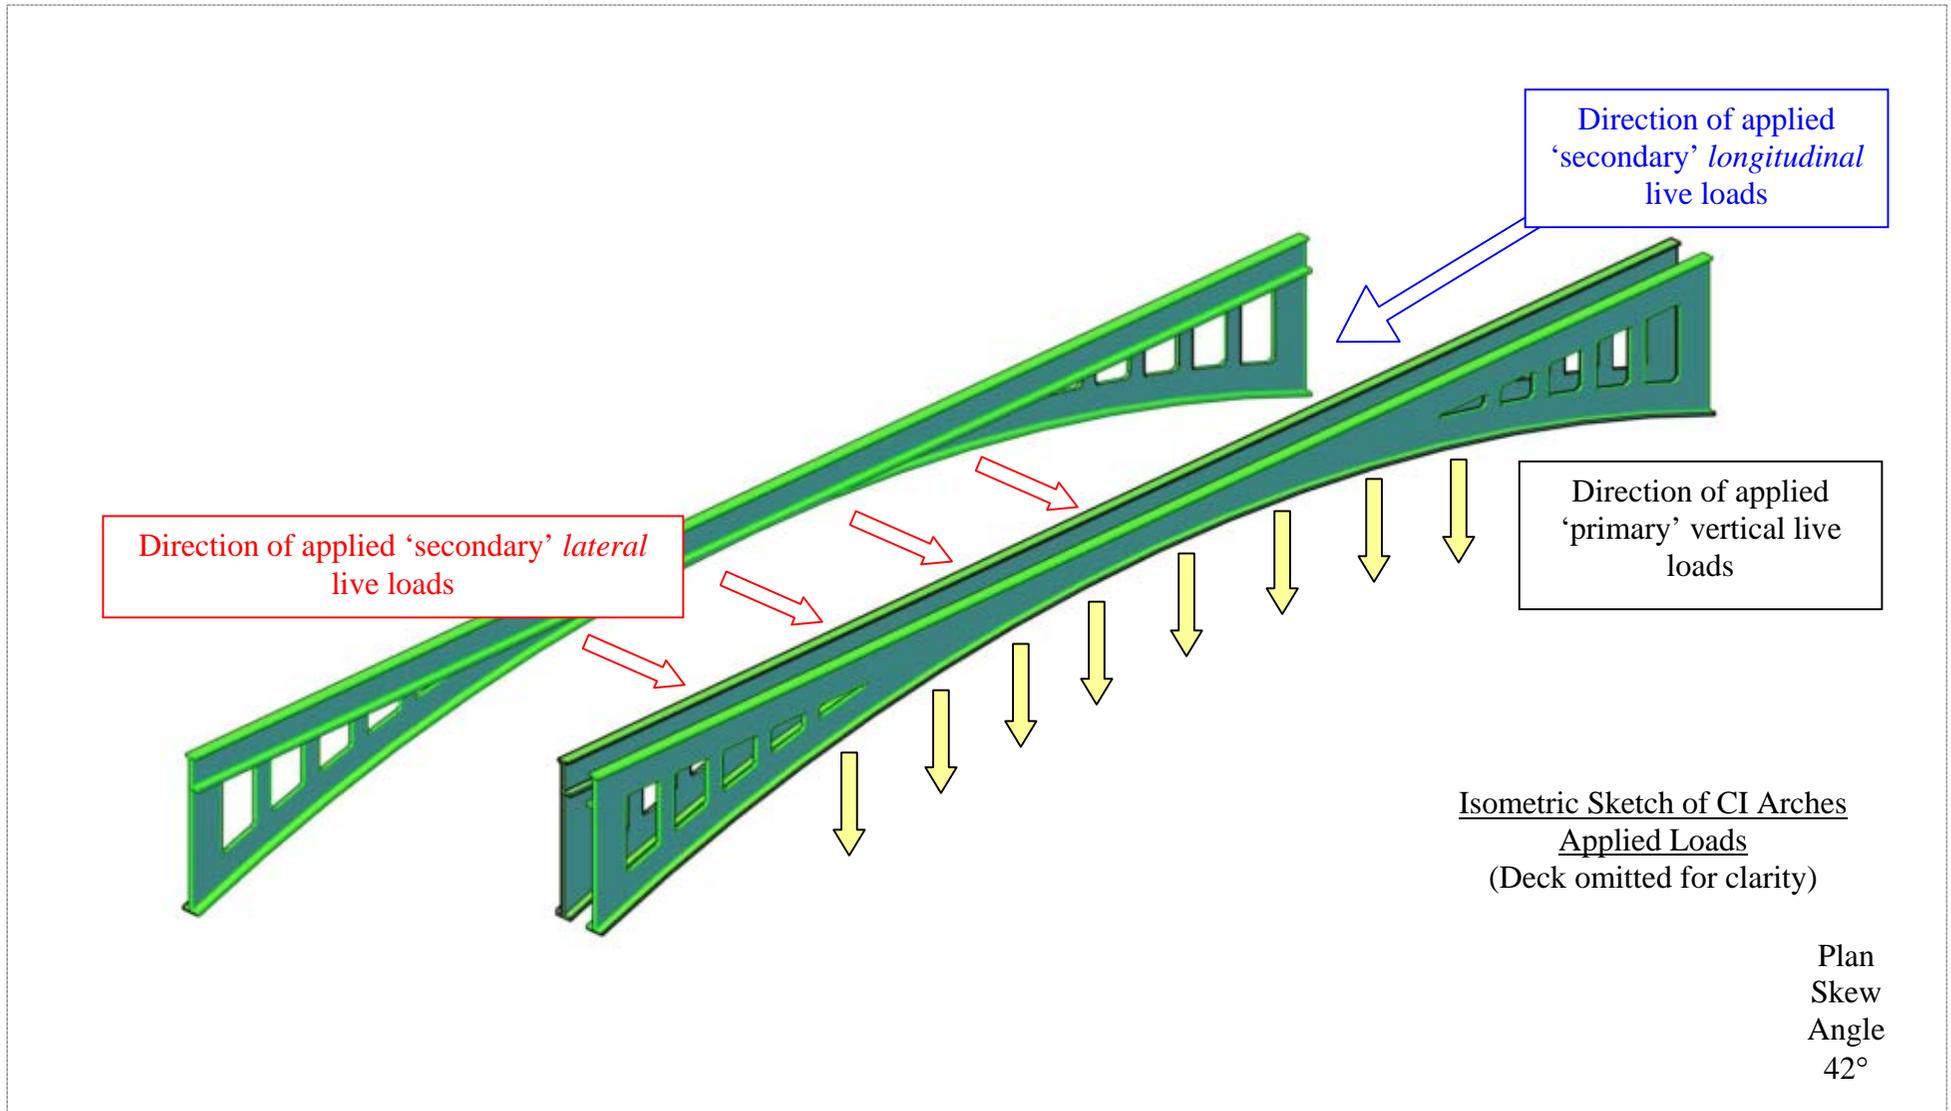
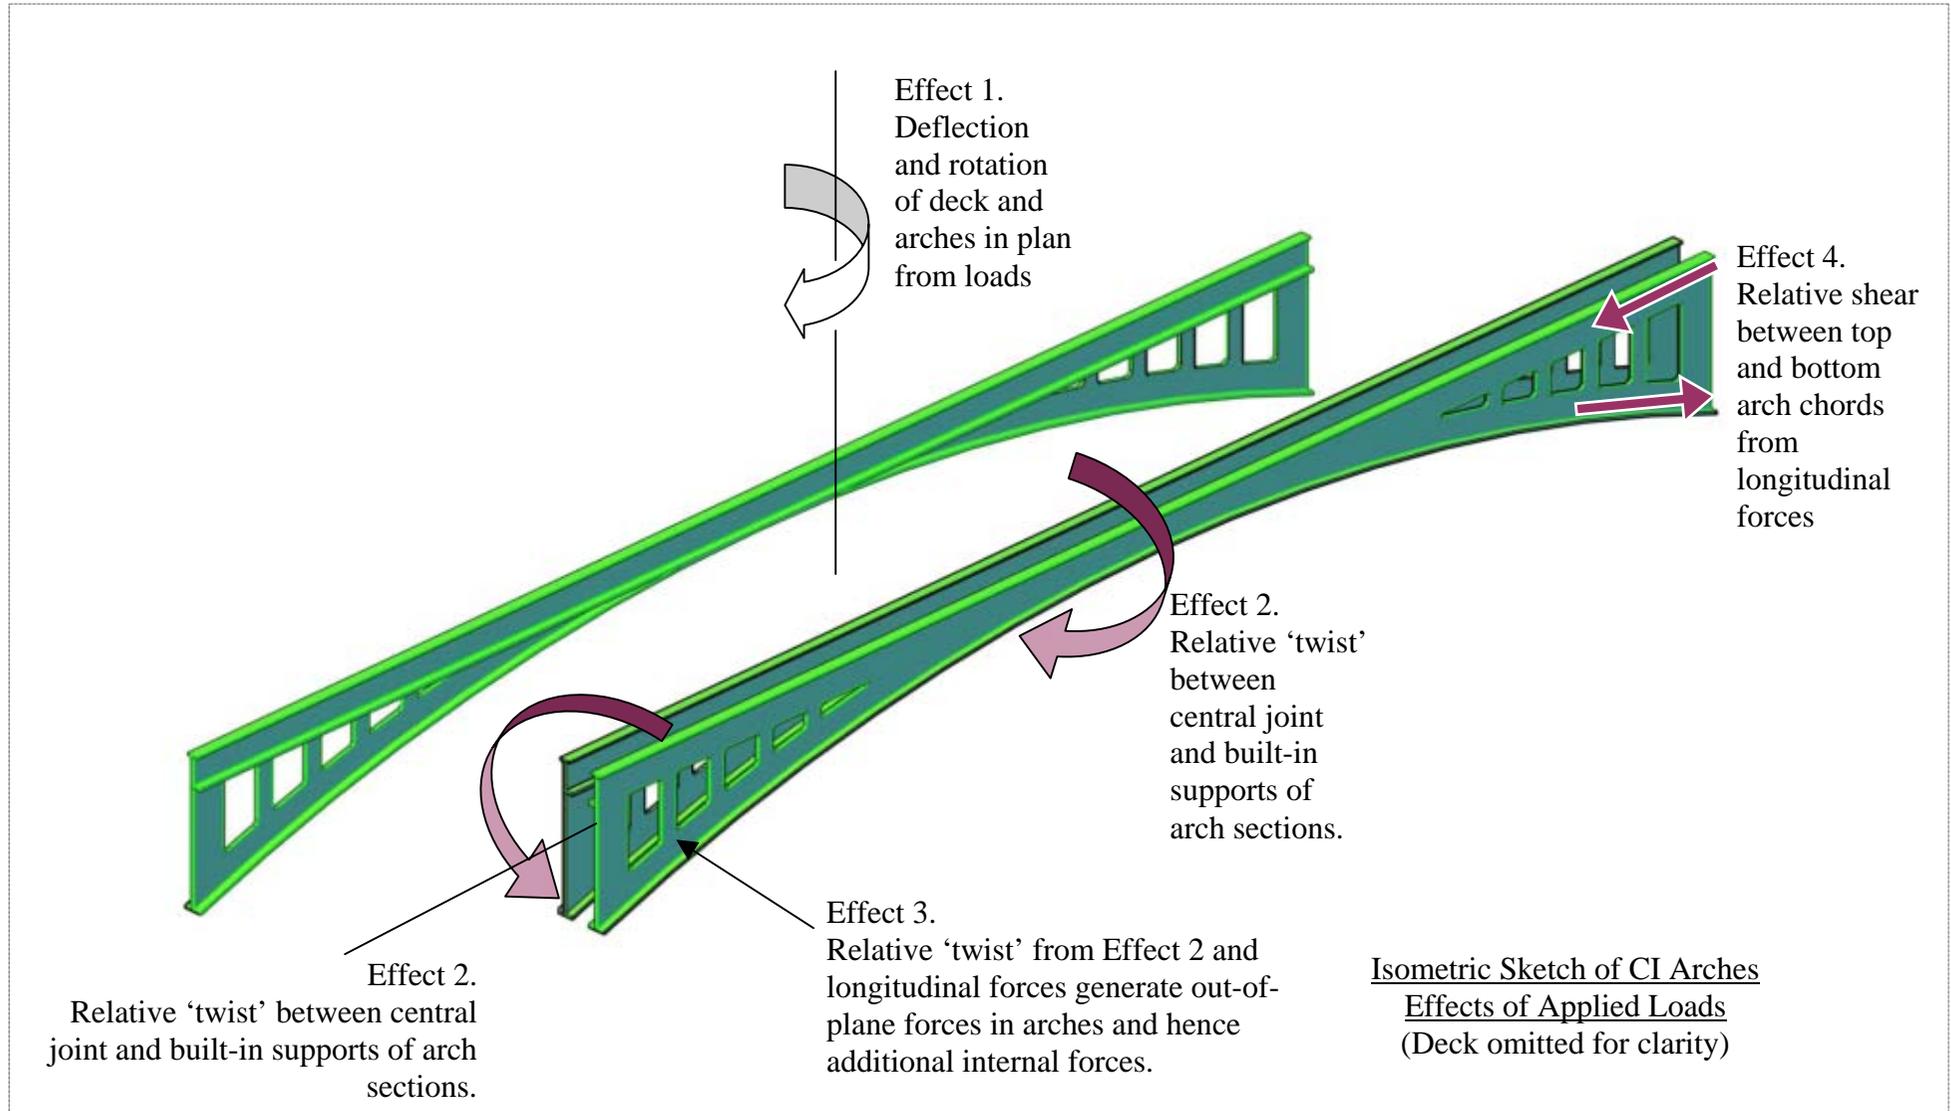
The sketches overleaf diagrammatically represent the applied loads from the relevant codes of practice, and the resulting effects. This demonstrates that the effects of the design loads give rise to increased stresses and deflections into a structure already assessed as being over capacity.

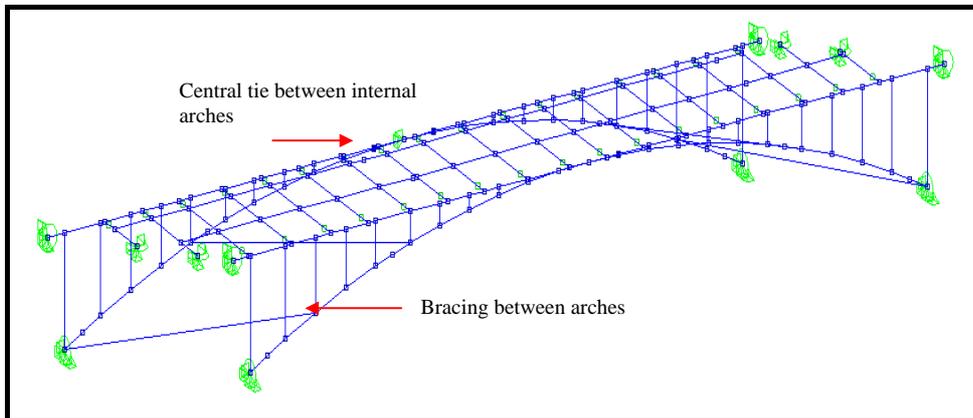
A 3D space frame model of the cast iron arches and wrought iron crossgirders has been developed in a structural analysis programme (Superstress version 6.7C manufactured by Integer). The model can be seen in figure 1:-

Figure 1 3D space frame model of BEJ42

The model represents two cast iron arches supporting cross girders and one track. The geometry of the 3D space frame has been developed from topographical survey data in conjunction with archive drawing information. The information gained in determining the section properties were confirmed on site from tactile investigations. Therefore the section properties used in the analysis are representative of insitu conditions. The orientation is representative of the eastern side of the superstructure carrying the Up Main railway line between Buxton and Edgley Junction.

Each line of the model shown in figure 1 represents the relative sectional and torsional properties of the arch and cross members. The rails are represented by the longitudinal properties of the deck system.

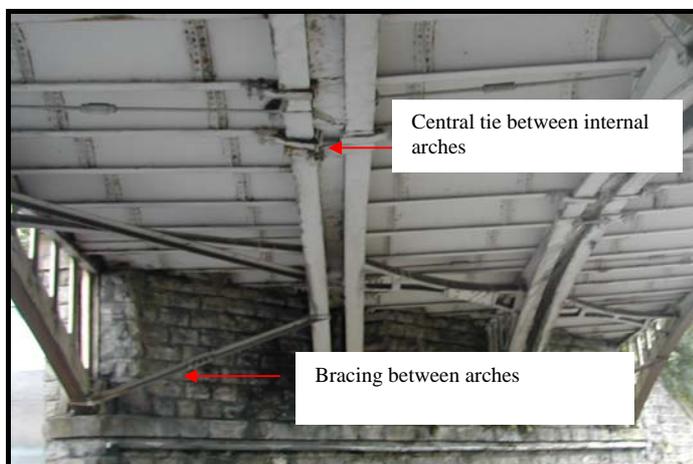
Figure 2 Location of bracing

The model is limited to two arches as the fixity between arches is limited to the midspan location only, this is shown in figure 2. The central tie will not allow any transfer of vertical load into the adjacent arch. It may provide limited lateral restraint from horizontal forces induced by railway traffic loading. The tie has been represented in the model as a lateral support shown in figure 1 at midspan. The bracing shown in figure 2 has also been incorporated into the model, again this is not considered as fully effective due to the limited fixity between the bracing and the cast iron, coupled with a shallow rake angle.

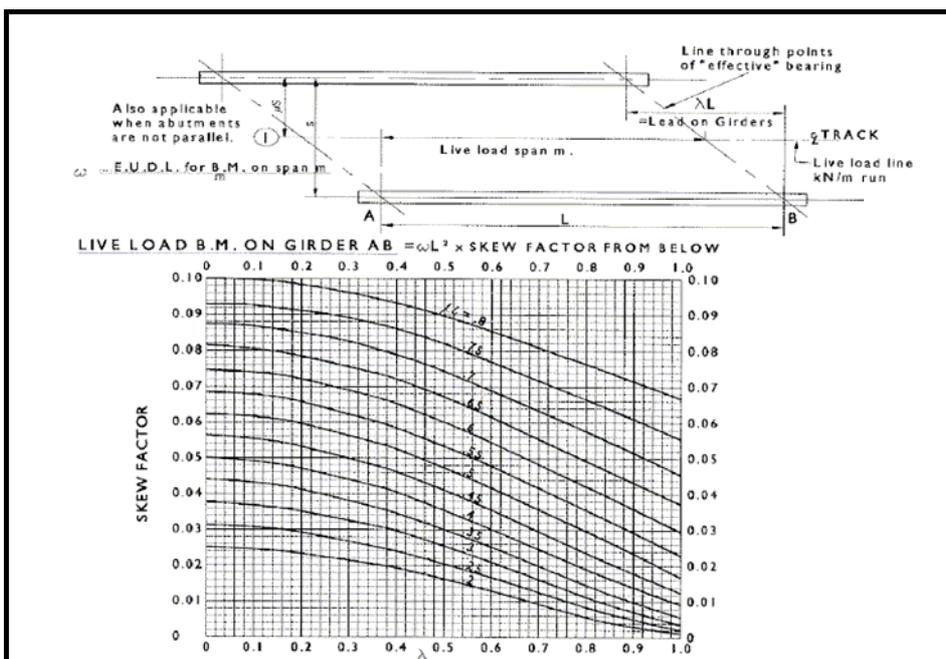
Figure 3 Live load skew parameters

The applied vertical railway traffic live load is taken from the most recent issue of Network Rail's assessment code NR/GN/CIV/025 issue 3. The loading used takes into account the bridge skew and therefore values for the live load span have been used. See figure 3 for outline derivation of live load.

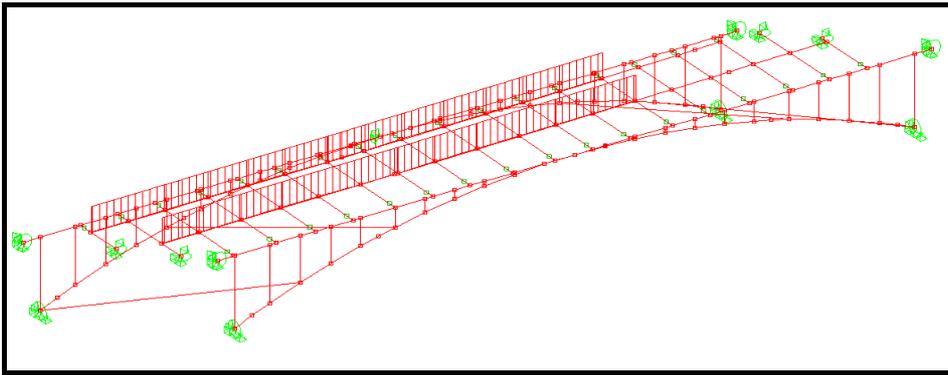
**Figure 4** Most onerous load case position

The most onerous load case assessed when considering the forces at the midspan connection is as a result of three quarter span vertical loading with lateral loading from centrifugal and nosing depicted in figure 4.

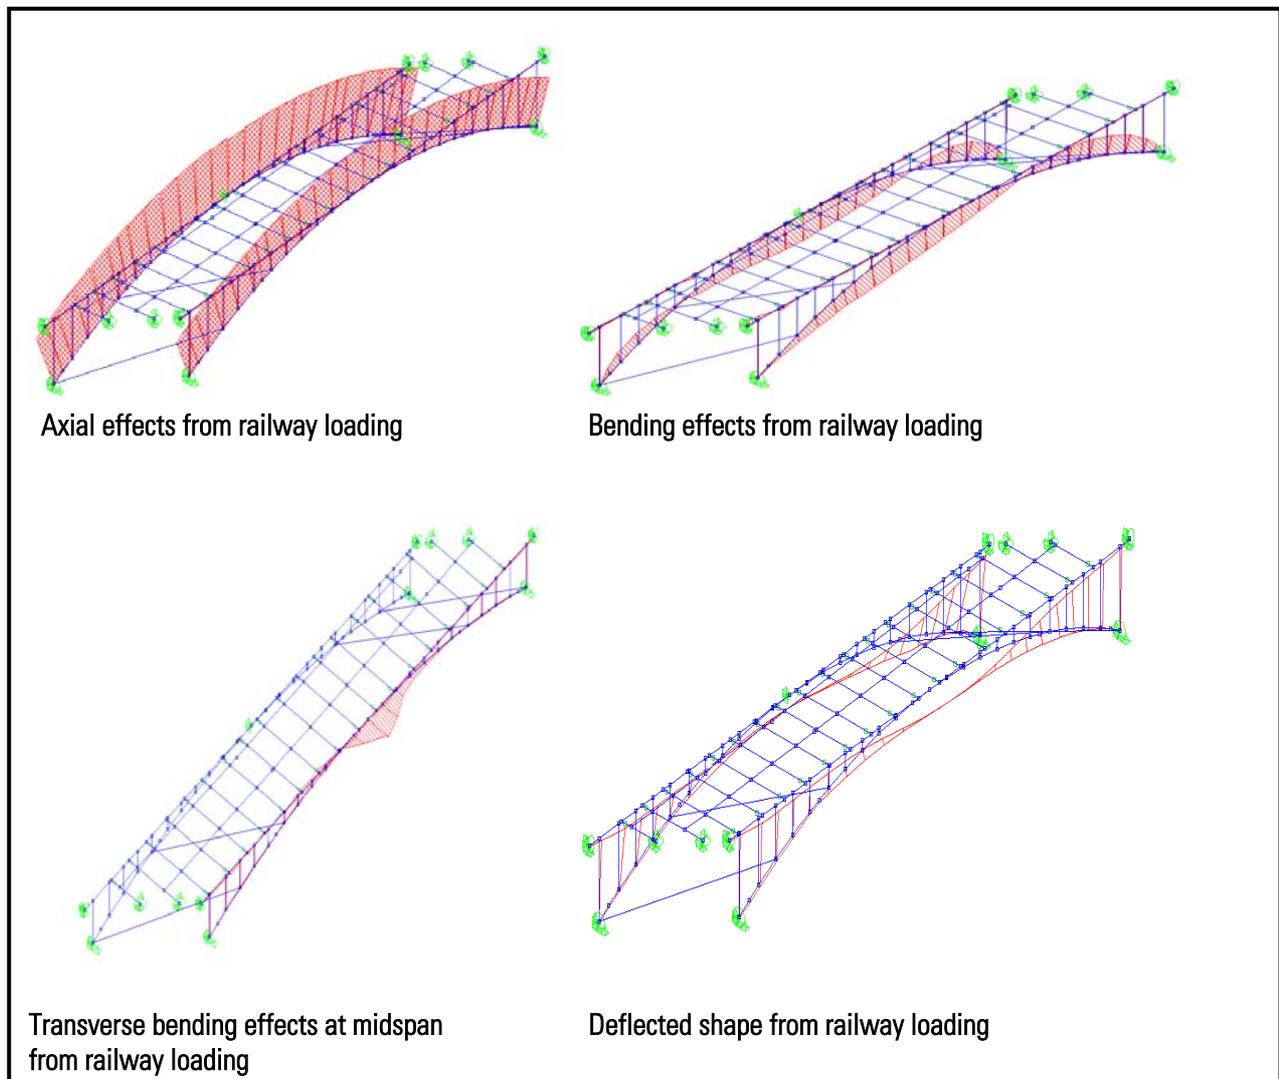
**Figure 5** Illustration of resultant effects from combined vertical and lateral effects.

The output of the 3D model demonstrates typical arch behaviour due to the applied loading. The effects of the loading are illustrated in figure 5.
